2024

# MAPPING ACCESSIBILITY ALONG THE HUNTOON TRAIL IN THE SEHOME ARBORETUM

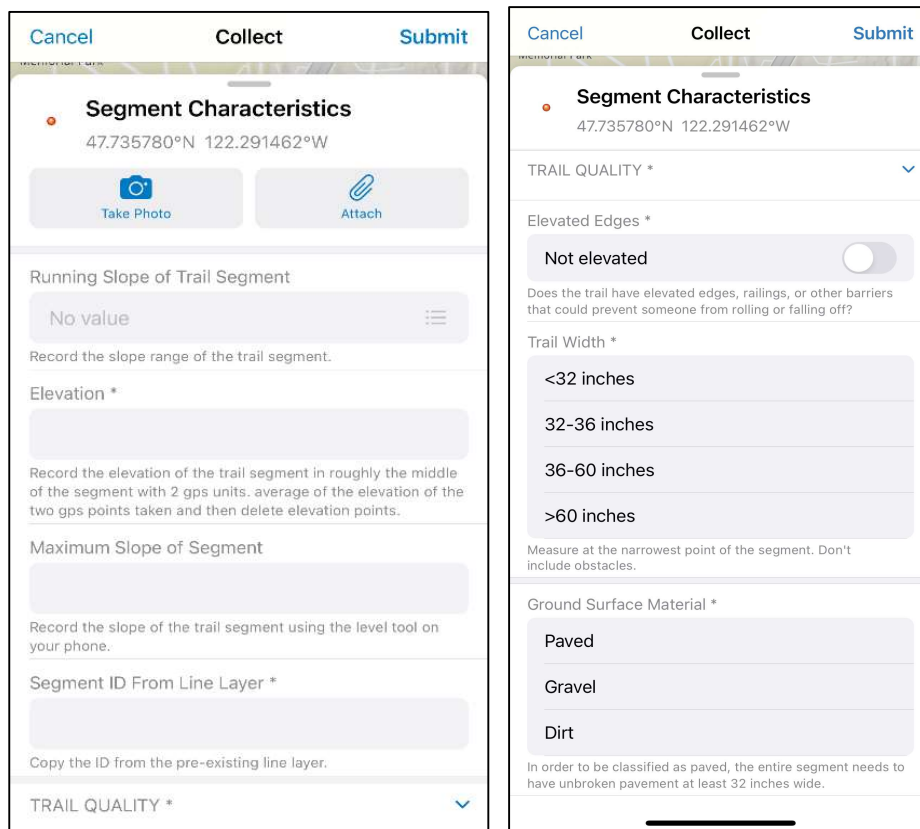
Figure 3. FieldMaps collection process for segment characteristics

Segment characteristics and trail observations were recorded independently within the FieldMaps application to keep the data separate when conducting analysis. The required segment characteristics were attributes such as slope, trail width, ground surface material, elevation, and whether the segment had elevated edges. Slope, surface material, and elevated edges were primarily used in analysis. Attributes such as trail width, slope, surface material, and elevated edges were primarily used in analysis. Slopes were categorized as under 5%, 5% to 10%, or over 10% in line with current research and existing standards and was collected using the Apple measure app with IOS16 compatibility on the visually estimated steepest portion of the trail (Lepoglavec et al., 2023; United States Access Board, 2010). Surface material was categorized as either paved, gravel, or dirt. To ensure segments marked as paved were fully paved, any segment containing a mix of paved and unpaved surfaces was counted as the unpaved surface, while distinctions between gravel and dirt surfaces were left to the discretion of the field collection teams. Elevated edges were defined as ridges along the trail edge, railings, or other barriers that could prevent a trail user from falling off the trail and counted only if both sides of the trail had some sort of incline or fence to keep hikers from falling over the edge of the trail.

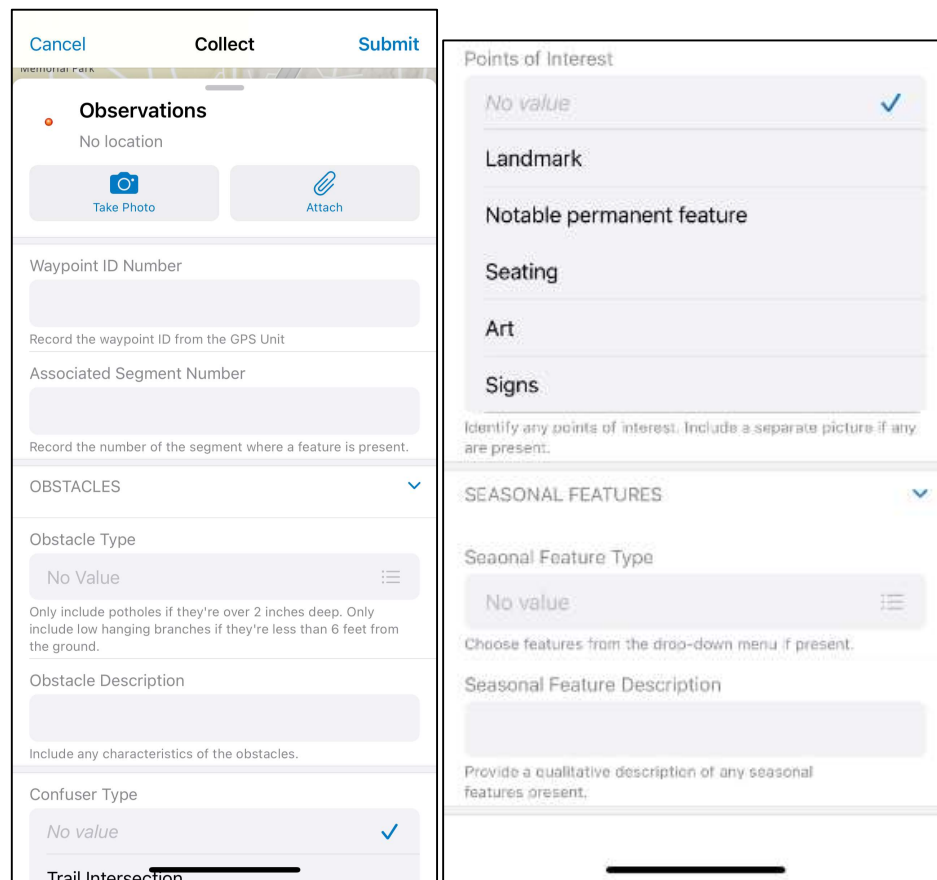
Figure 4. FieldMaps collection process for trail observations.

Trail observation characteristics were recorded as either an obstacle, a trail intersection, a point of interest, or a seasonal feature. An obstacle was defined as anything that might inhibit someone’s ability to traverse the trail and was an obstacle year-round such as rocks, roots, potholes, or low hanging branches. Low hanging branches were defined as being over the trail and under 203 centimeters from the trail surface (United States Access Board, 2010). A trail intersection was anything that might confuse someone. For example, a fork in the trail that a visually impaired person might not realize is a division of the trail. A point of interest was anything a hiker might want to stop and consider such as benches, trail markers and signs were included. Seasonal features were defined similarly to obstacles, but they only occurred at a certain point in the year, such as slick moss or patches of mud someone might slip on.

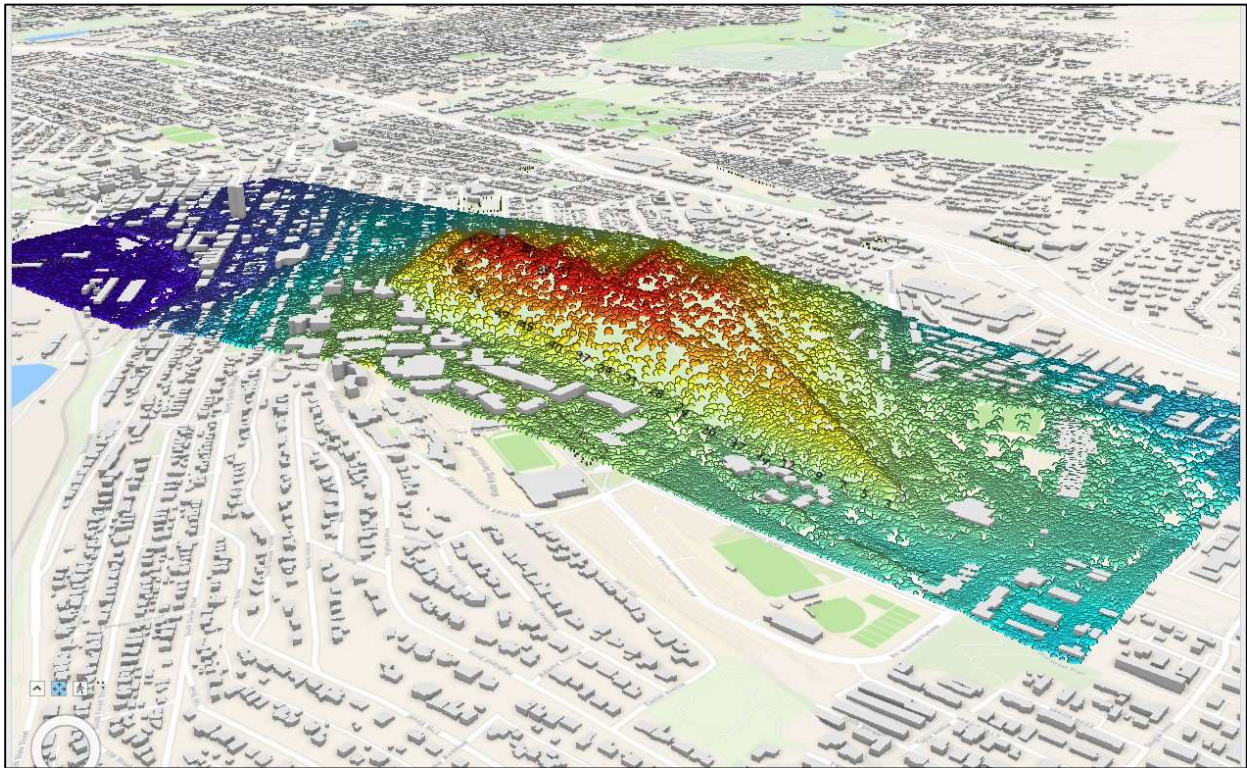
*Figure 5. LiDAR point cloud of the arboretum, combination of two point cloud layers.*

As mentioned previously, the slope of the trail was collected using the Apple measuring app and converted to grade percentage. For accuracy and additional analysis, that slope was compared to remote sensing data of the arboretum from 2013 in the form of point clouds. The point clouds were downloaded from the Washington State DNR LiDAR Portal in the form of LAZ files. The Convert LAS and Create LAS Dataset tools in ArcGIS Pro v3.2.2 were used to compile the LiDAR data into a single point cloud of the arboretum shown in Figure 5. The height for the LAS tool was set to use the NAD 1983 StatePlane Washington South Height US ft. The

Add Surface Information tool calculated slope statistics from the point cloud data and merge the data onto the 20-meter segments trail line. The slope calculated from the point clouds were used for cross-referencing the calculated slope from field collection and accessing the quality of the collected field data.

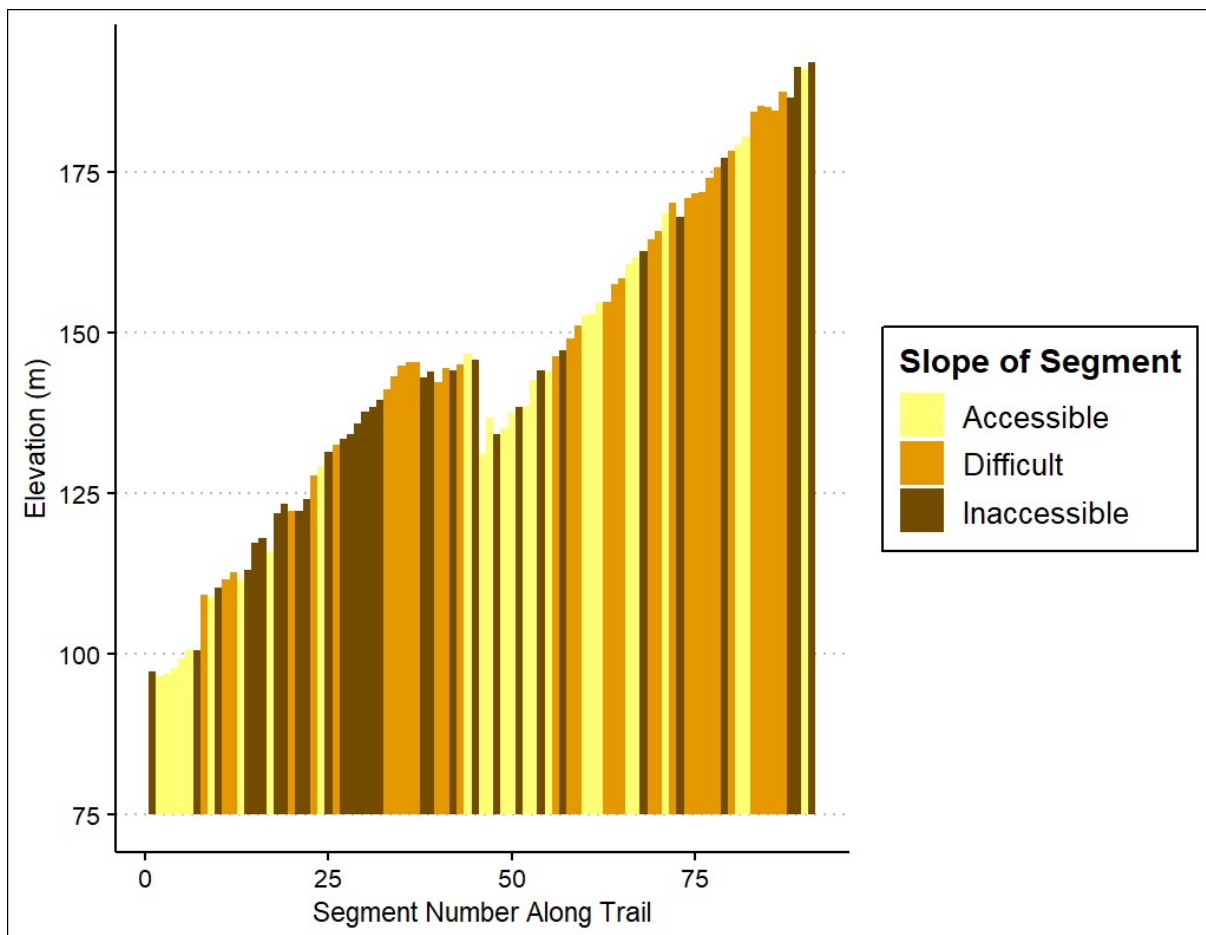
For each of the 92 trail segments, the percent gradient was calculated to determine accessibility based on slope. Of the 92 segments, 26 segments had a percent gradient of 5.5 percent or less, 34 of the segments had a grade between 5.5 and 9 percent, and 31 of the segments had a grade greater than 9 percent. The distribution of each segment with its corresponding slope and elevation is displayed in Figure 8. While Figure 9, provides an overhead view of the segments and their slope mapped along the Huntoon Trail.

Figure 8. This chart graphs both the elevation and slope of each segment along the Huntoon Trail. Slope accessibility defined 0 – 5.5 % grade as “Accessible”, 5.5 – 9 % grade as “Difficult”, and >9 % grade as “Inaccessible”.

The majority of the Huntoon Trail would be considered inaccessible by the standards of this study. The slope is generally far too steep for wheelchair users to navigate safely, and a myriad of obstacles are scattered throughout the length of the trail. Only 26 of the 92 20-meter segments, comprising approximately 28% of the trail, had a low enough grade (5%) to meet ADA standards for people using wheelchairs (2010 ADA Standards for Accessible Design). Modifying this grade to be accessible for wheelchair users would require the construction of an entirely new trail, as the current grade reflects that of the original road that was built in 1923. This would involve removing dozens, if not hundreds, of mature trees within the arboretum and would require significant funds. Because the arboretum was founded as a natural area with the intent of preserving the second-growth forest that grew after it was originally logged (Sehome Arboretum Master Plan, 2002), this approach would face vigorous opposition if formally

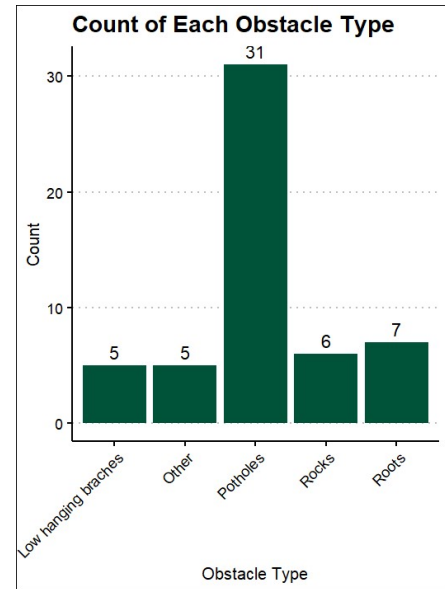
A total of 54 obstacles were observed across the five categories, with a count of 31 potholes, 7 roots, 6 rocks, 5 low hanging branches, and 5 obstacles classified as ‘other’ as shown in Figure 11. Observation descriptions for roots included cracking of trail pavement and a root that impacted the entire width of the trail in Segment 15. Low-hanging branches were observed in Segments 3, 4, 5, and 6. The observations for rocks identified areas of sparse pavement and persistent rocky sections in trail segments 44, 45, 67, 68, 69, and 70. Obstacles classified as ‘other’ noted downslope in the trail in segments 76, 79, and 90; as well as downed logs near the trail and a section of stairs in segment 1. A detailed map of the observed obstacles can be found in Figure 13.

Figure 11. This bar graph displays the count of each obstacle observed by the data collection team.

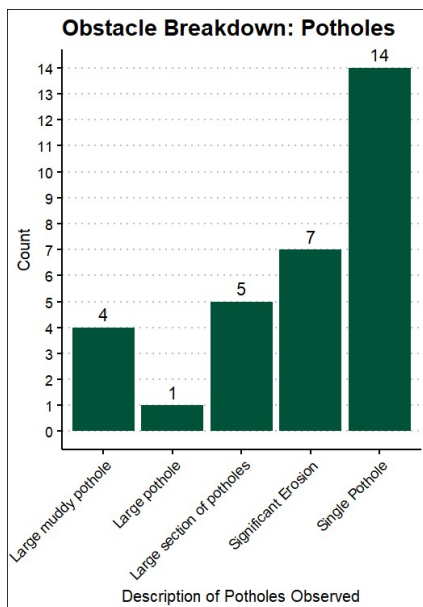
Figure 12. This figure shows the breakdown of the different descriptions of potholes observed.

With 31 observations, a breakdown of the observed potholes and their characteristics is shown in Figure 12. The majority of pothole observations included single potholes with a count of 14 observations throughout the Huntoon Trail. The second highest observations indicated significant erosion in segments 41, 47, 49, 56, 57, 62, and 64. Large sections of potholes were observed in segments 31, 57, 60, 88, and 91. Lastly, large potholes were observed in segments 28, 47, 56, 62, and 63.

ensure everyone has equal accessibility. Repaving the trail surface could also help with the issue of trail erosion. Segments 41, 47, 49, 56, 57, 62, and 64 were all observed to have significant erosion, and since these sections have been previously paved, repaving them to fix the erosion would be feasible. To prevent further erosion, adding raised edges such as retaining boards on the downslope side of the trail could be beneficial. These would use the principle behind terraces used in areas of steep agriculture to add support to the material underneath the pavement and prevent it from sliding downhill and leaving the pavement unsupported and vulnerable.
